**TEARDOWN REPORT  
OF TWO MODEL TPE331-10T-515K TURBOPROP ENGINES  
SERIAL NUMBER P-79297C AND P-79001C**

**October 8, 2014**

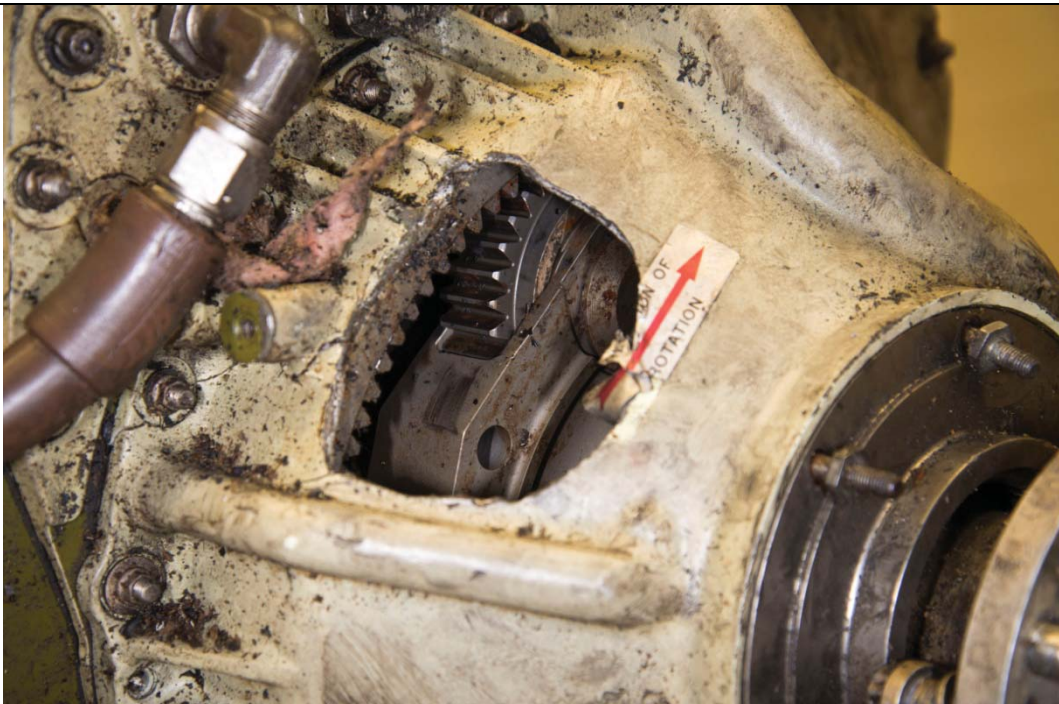
**Figure 8.** P-79297C, Impact Damage

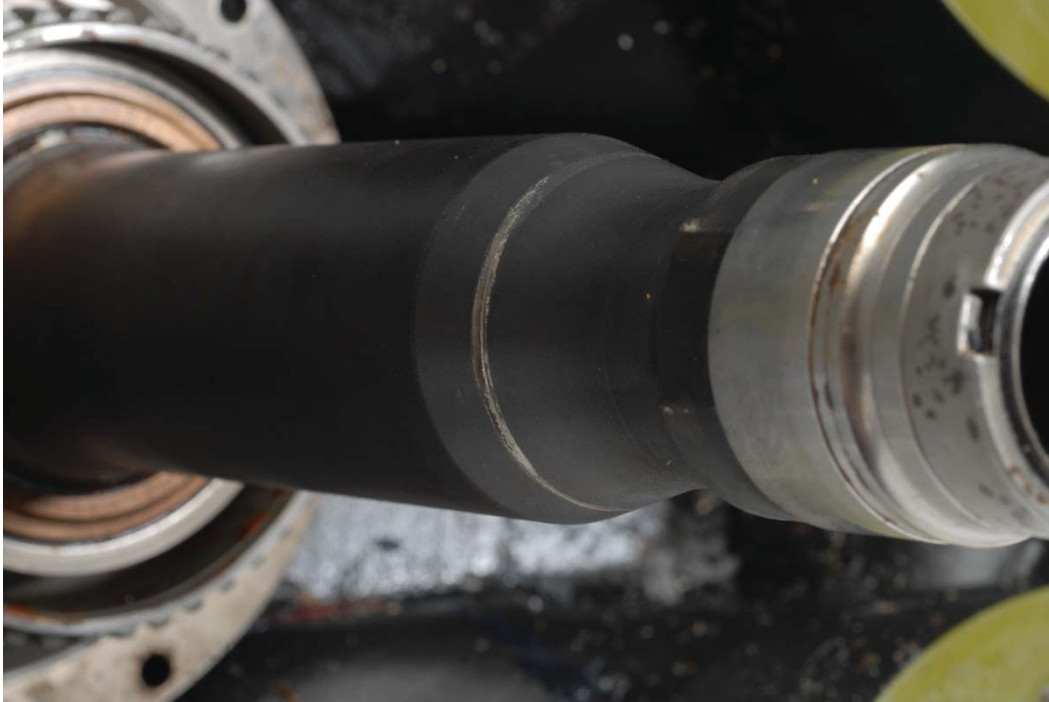
- The nuts from the forward propeller shaft bearing mount bolts had been displaced aft.
- (e) Propeller Shaft:
  - The propeller shaft displayed rotational scoring through 360 degrees immediately aft of the propeller shaft nut with corresponding rotational score marks on the sun gear forward inner bore. (Figure 24)

**Figure 25.** P79297C, Propeller Shaft Rotational Scoring, Aft Taper

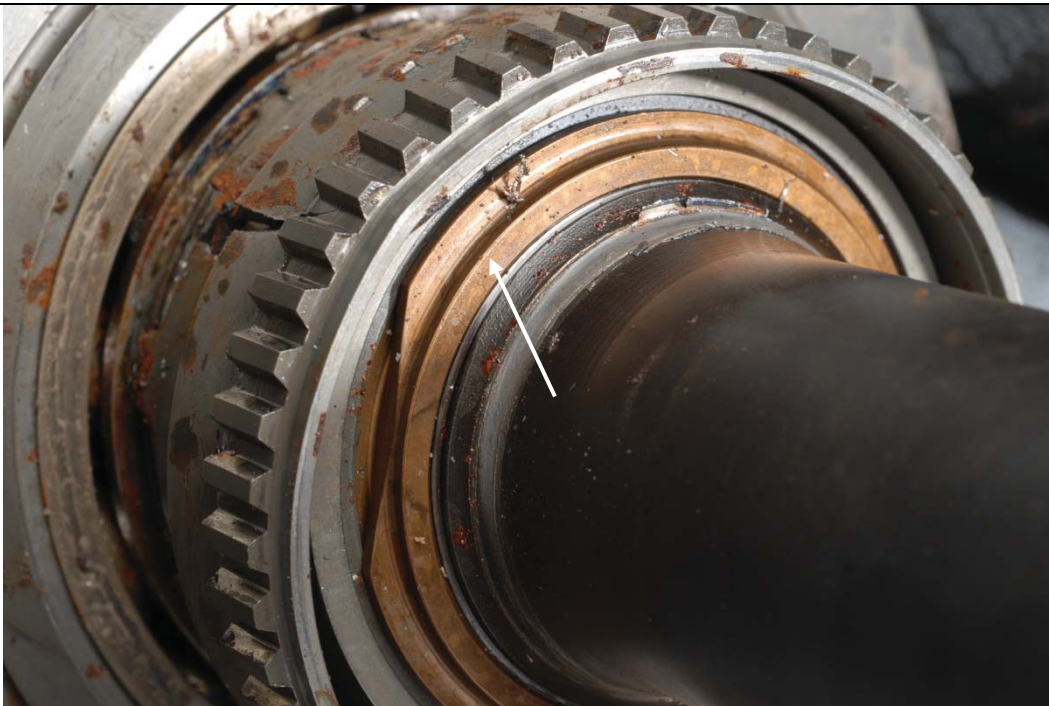
- The propeller shaft displayed rotational scoring through approximately 360 degrees on the aft taper, with corresponding rotational score marks on the sun gear aft inner bore. (Figure 25)

**Figure 26.** P-79297C, Propeller Shaft Lock Nut

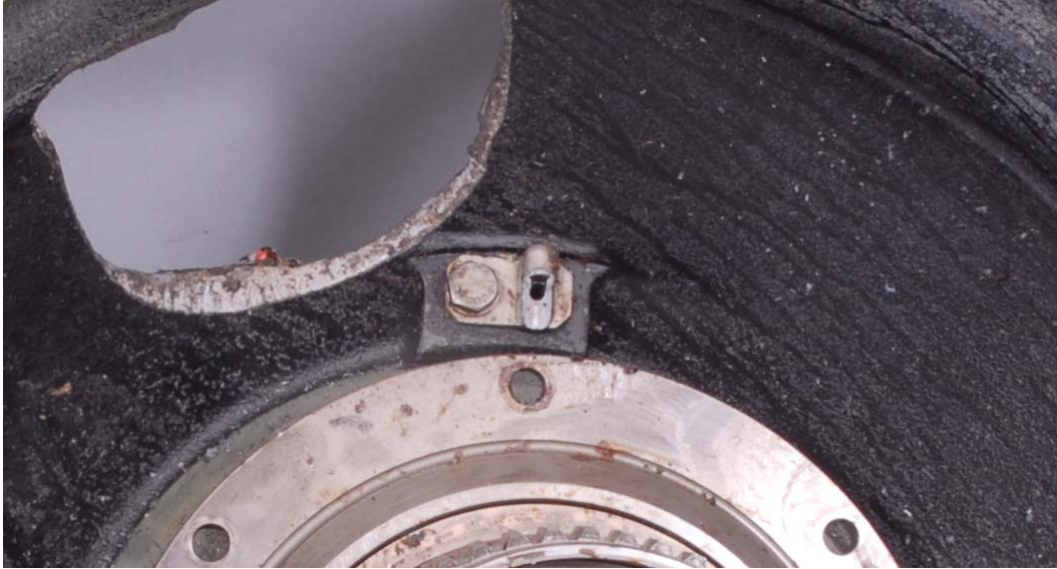
**Figure 27. P-79297C, Propeller Shaft Oil Jet**

- (f) Propeller Shaft Lock Nut: (Figure 26)
  - The propeller shaft lock nut appeared to be intact but was not removed from the shaft.
- (g) Propeller Shaft Output Seal Retainer:

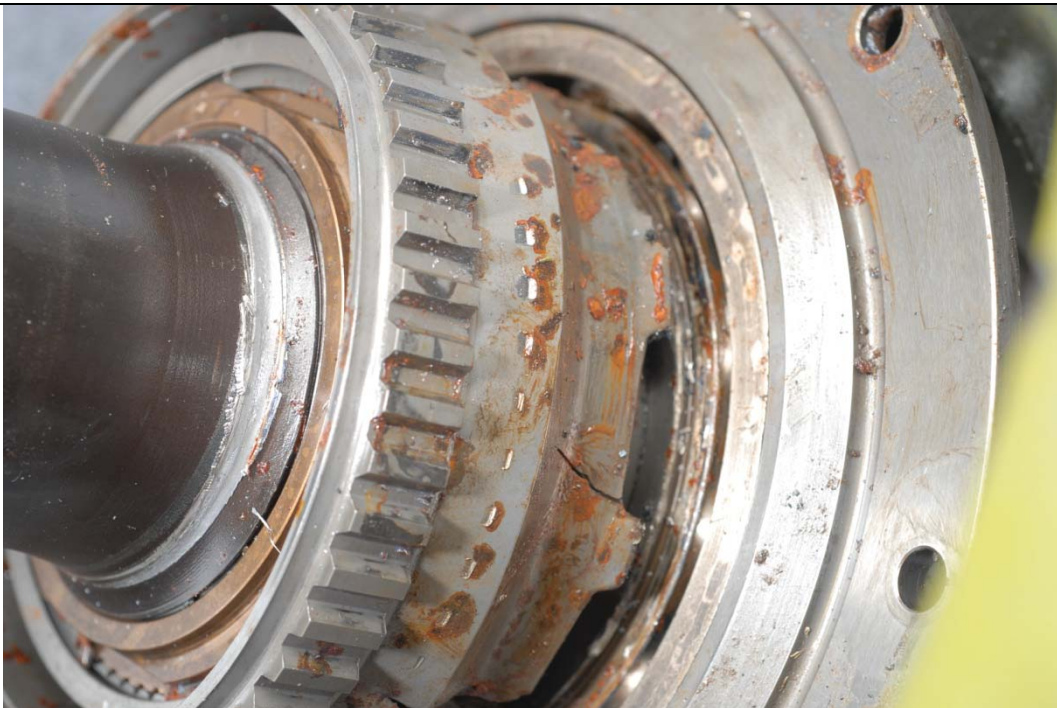
**Figure 28. P-79297C, Propeller Shaft Coupler**

- The propeller shaft output seal retainer was not accessed during the examination.
- (h) The Propeller Shaft Bearing Oil Jet: (Figure 27)
  - The propeller shaft bearing oil jet was intact, but was displaced aft.

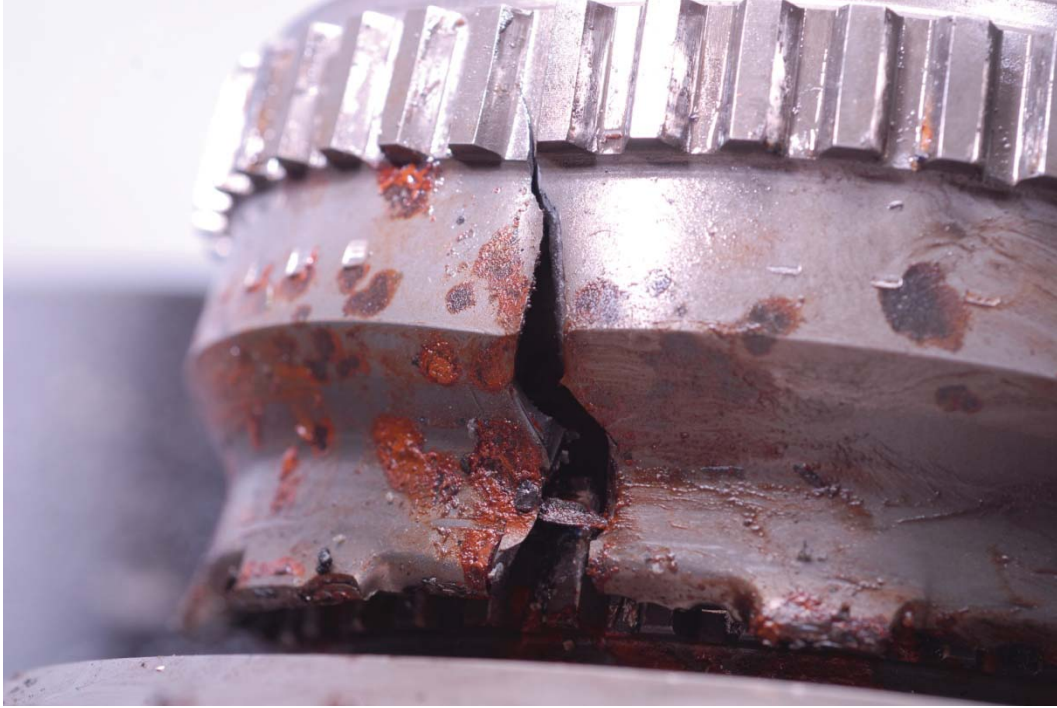
- (j) Propeller Shaft Bearing:
  - The propeller shaft bearing was not disassembled but rotated with resistance.
- (k) Propeller Shaft coupler: (Figure 28 and Figure 29)

**Figure 29.** P-79297C, Propeller Shaft Coupler, Impact Damage

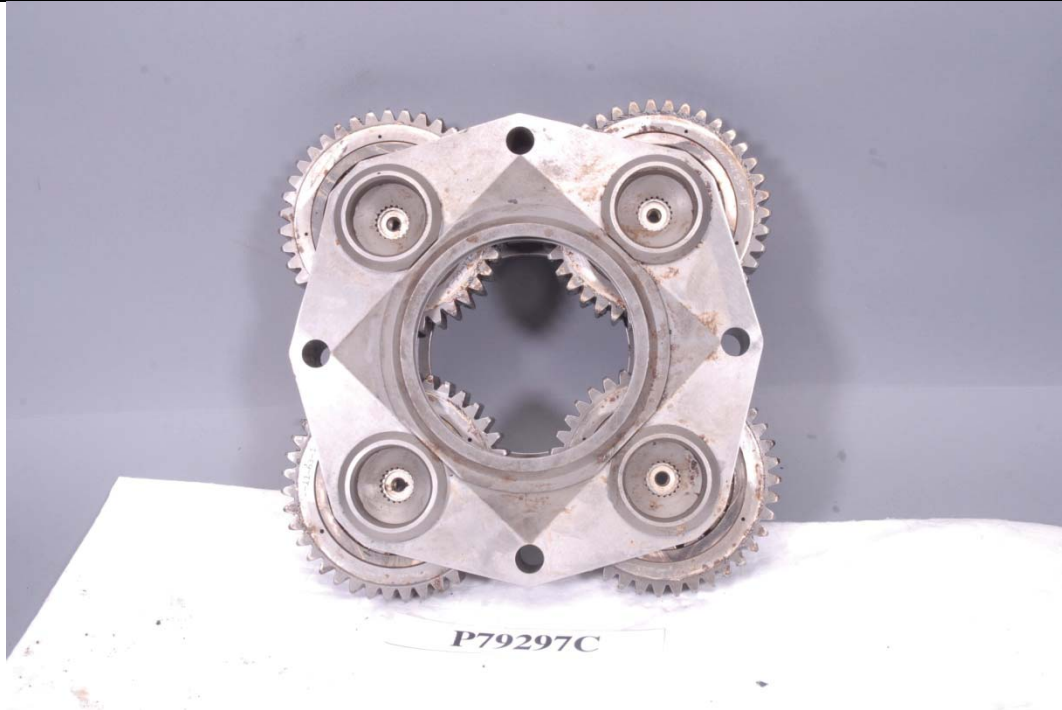
- (a) Planetary Gear Assembly: (Figure 30 and Figure 31)
  - The planetary gear assembly was intact.
  - All of the planetary gear assembly gears/bearings rotated with resistance.

**Figure 31.** P-79297C, Planetary Geat Assembly, ALF

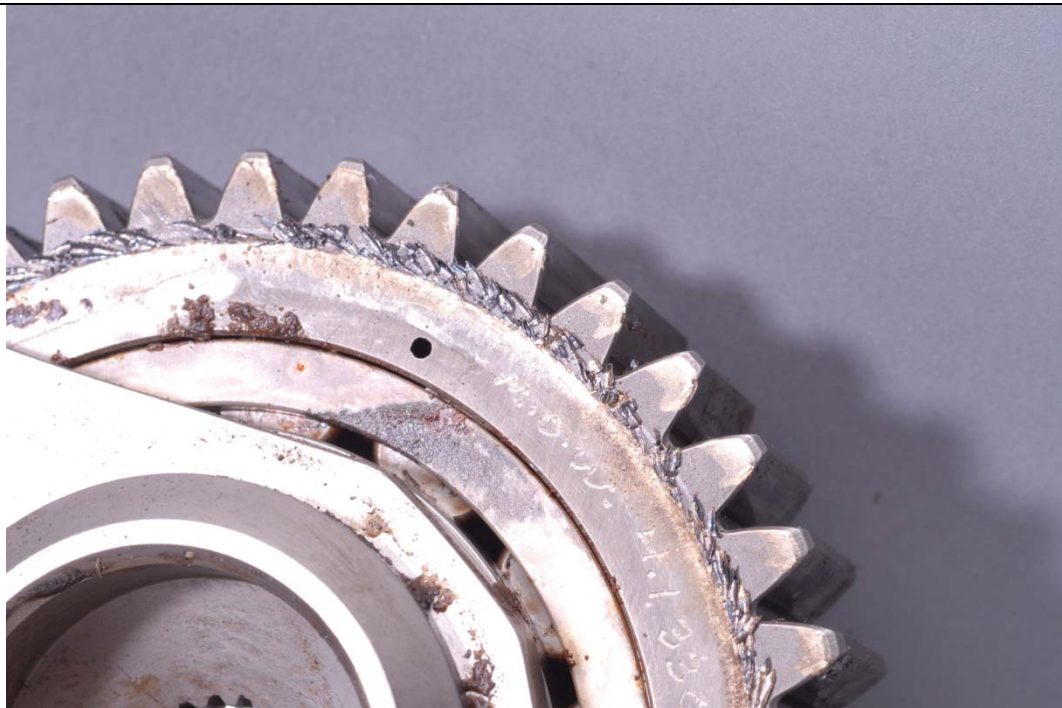
**Figure 32.** P-79297C, Planetary Gear Score Marks (6), FLA

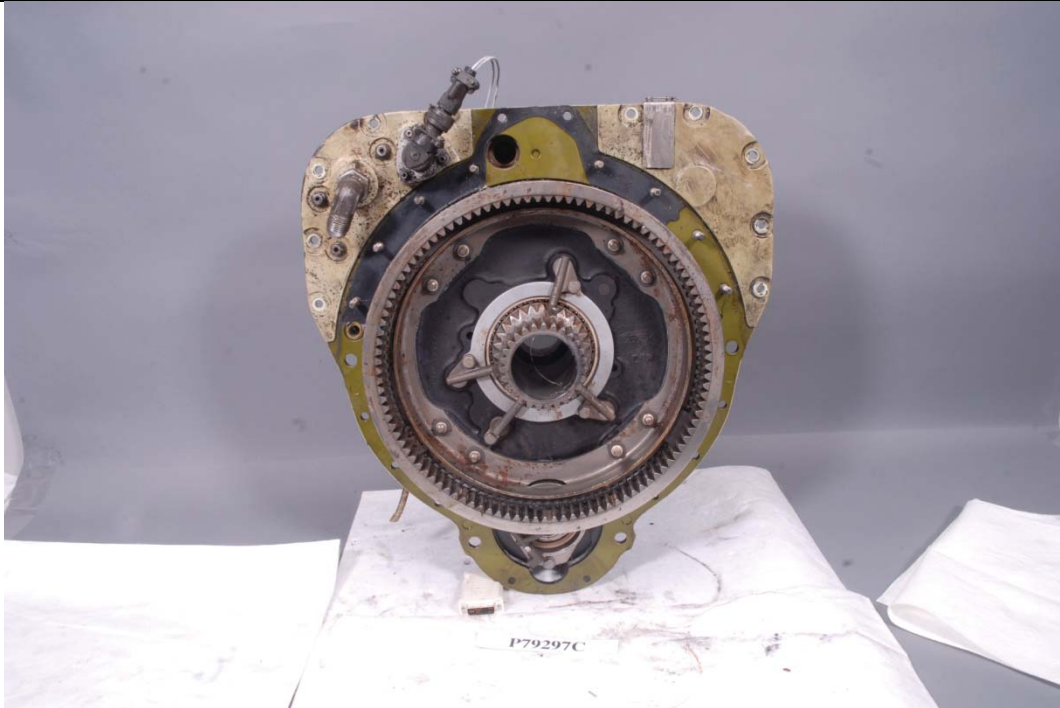
- All of the planetary gears exhibited rotational scoring to the aft face (Figure 32) with corresponding score marks on the ring gear support (bumper plate).

**Figure 33.** P-79297C, Ring Gear Assembly Installed in Intermediate Case, FLA

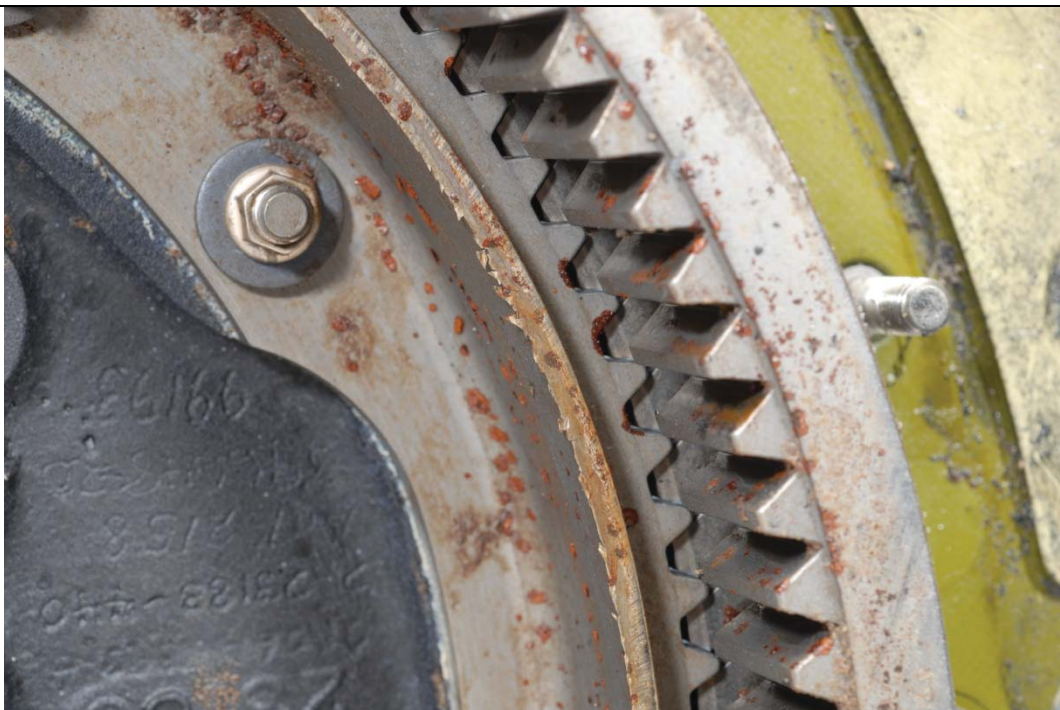
- All of the planetary gear teeth were intact.
  - The planetary gear assembly was not disassembled for a detailed inspection.
- (b) Ring Gear: (Figure 33)

**Figure 34.** P-79297C, Ring Gear Bumper Plate Scoring Marks, FLA

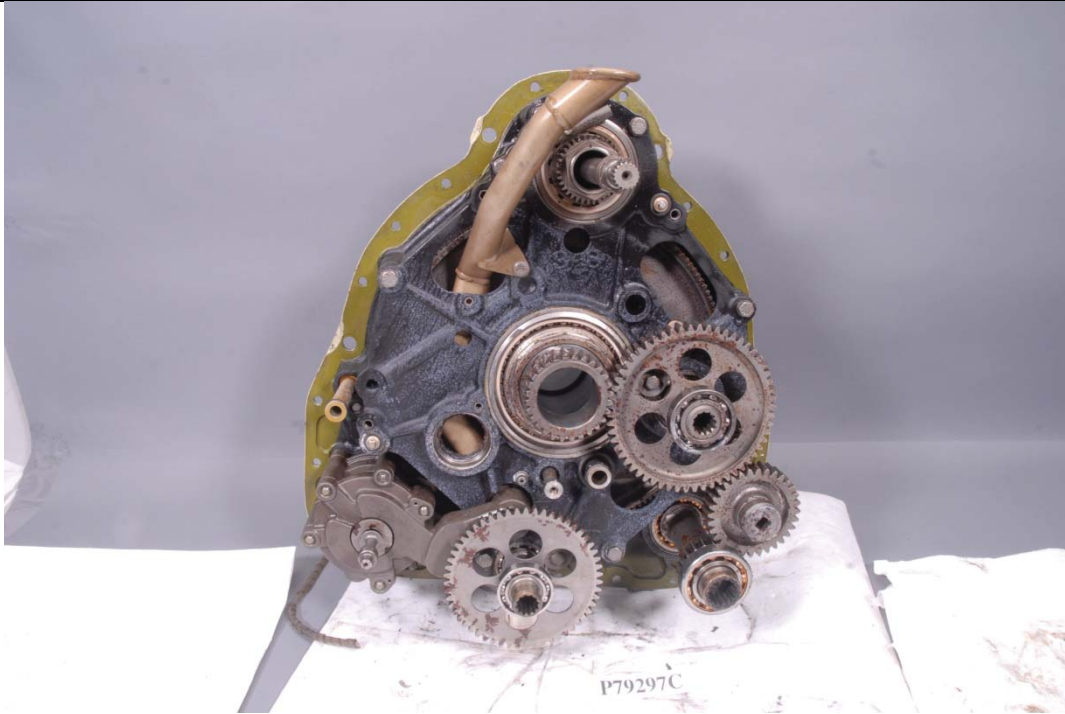
**Figure 35. P-79297C, Diaphragm Housing, ALF**

- The ring gear was intact.
- (c) Ring Gear Support:
  - The ring gear support was intact.
  - The ring gear support (bumper plate) displayed rotational scoring to the forward face. (Figure 34) with corresponding score marks on the aft face of all of the planet gears.

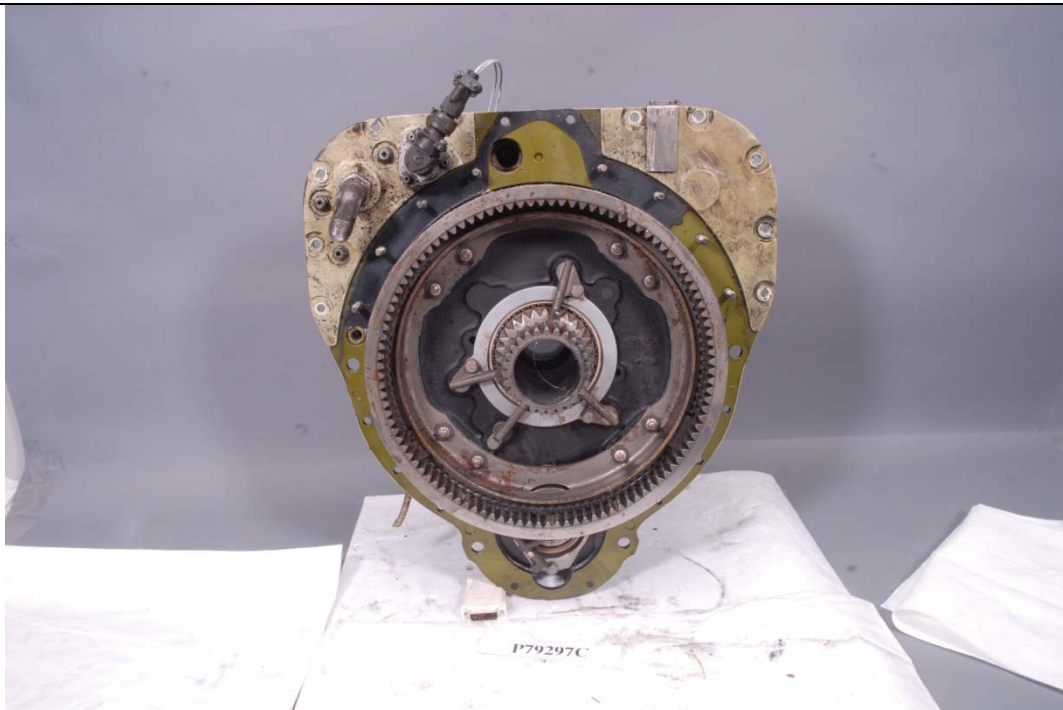
**Figure 36. P-79297C, Diaphragm Housing, FLA**

- (d) Ring Gear Retainers:
  - The ring gear retainers were in place and appeared to be undamaged but were not removed for a detailed examination.
- (e) Diaphragm Housing Assembly: (Figure 35 and Figure 36)

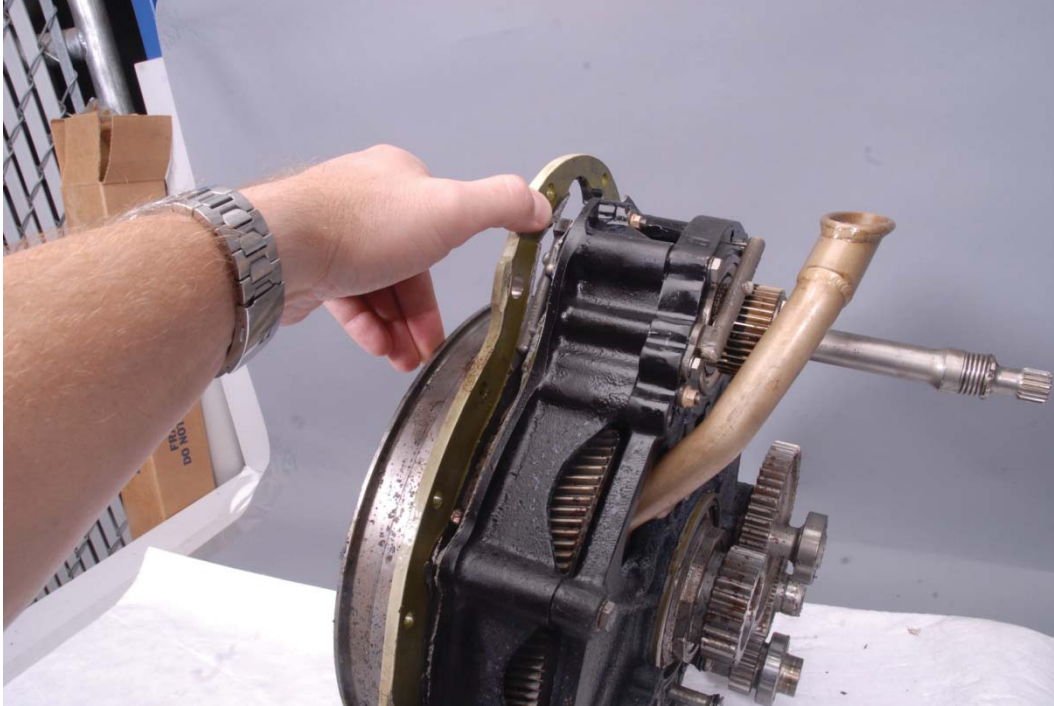
**Figure 37. P-79297C, Diaphragm Housing Fracture**

- All gears and bearings of the diaphragm housing were intact. All gears were free to rotate.
  - The diaphragm housing mount flange was fractured from the housing from the 2 to 9 o'clock position. (Figure 37)

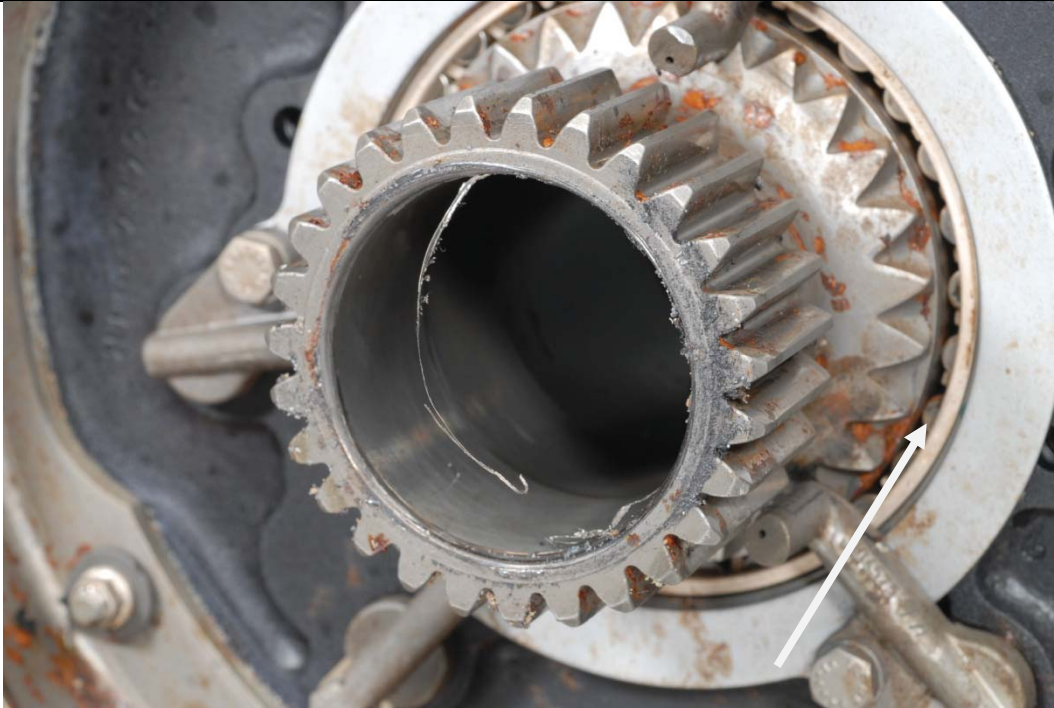
- (g) Forward Bull Gear Bearing: (Figure 39)
  - The forward bull gear bearing appeared to be intact, but was not removed from the diaphragm assembly.
- (h) Aft Bull-Gear Bearing:

**Figure 39.** P-79297C, Forward Bull Gear Bearing

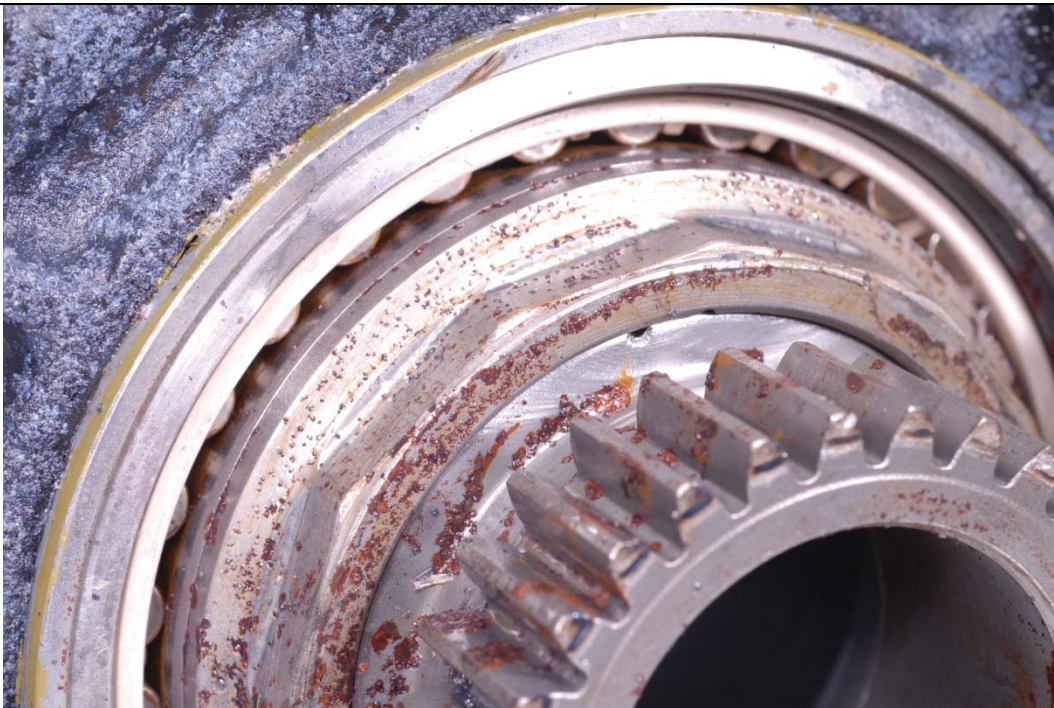
- The aft bull-gear bearing liner was displaced aft in the diaphragm housing. (Figure 40)
  - The aft bull-gear bearing liner displayed an impact mark (Figure 41), with a corresponding impact mark on the feather valve oil transfer tube boss.

**Figure 40.** P-79297C, Aft Bull Gear Bearing and Liner, Displaced Aft

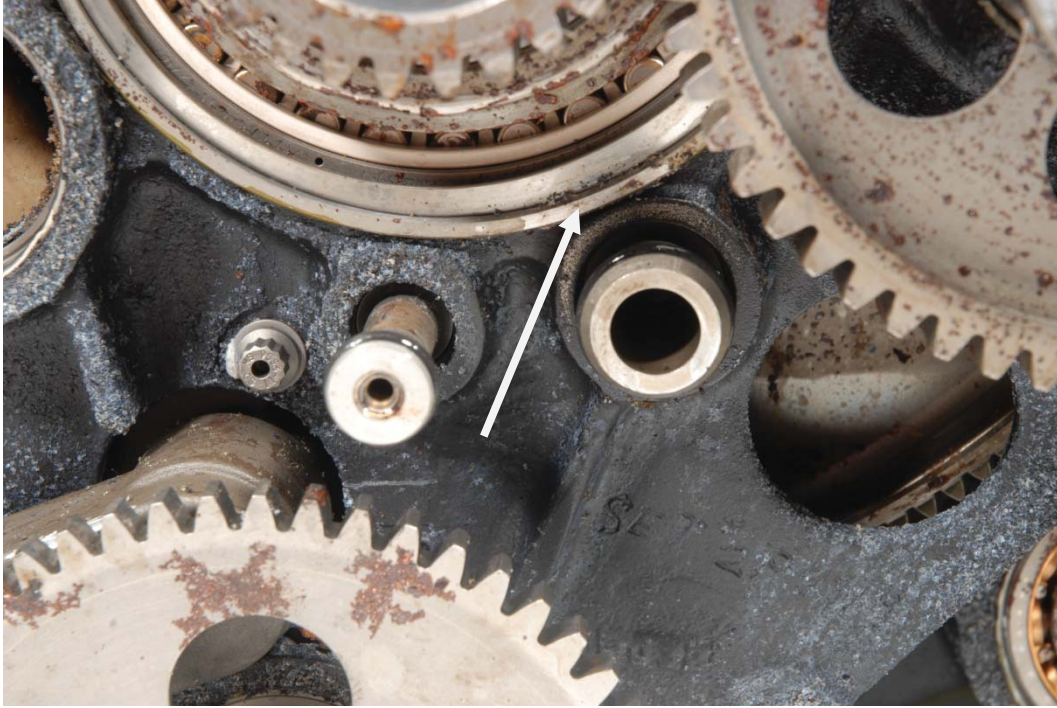
**Figure 41.** P-79297C, Aft Bull Gear Bearing Liner Impact Mark

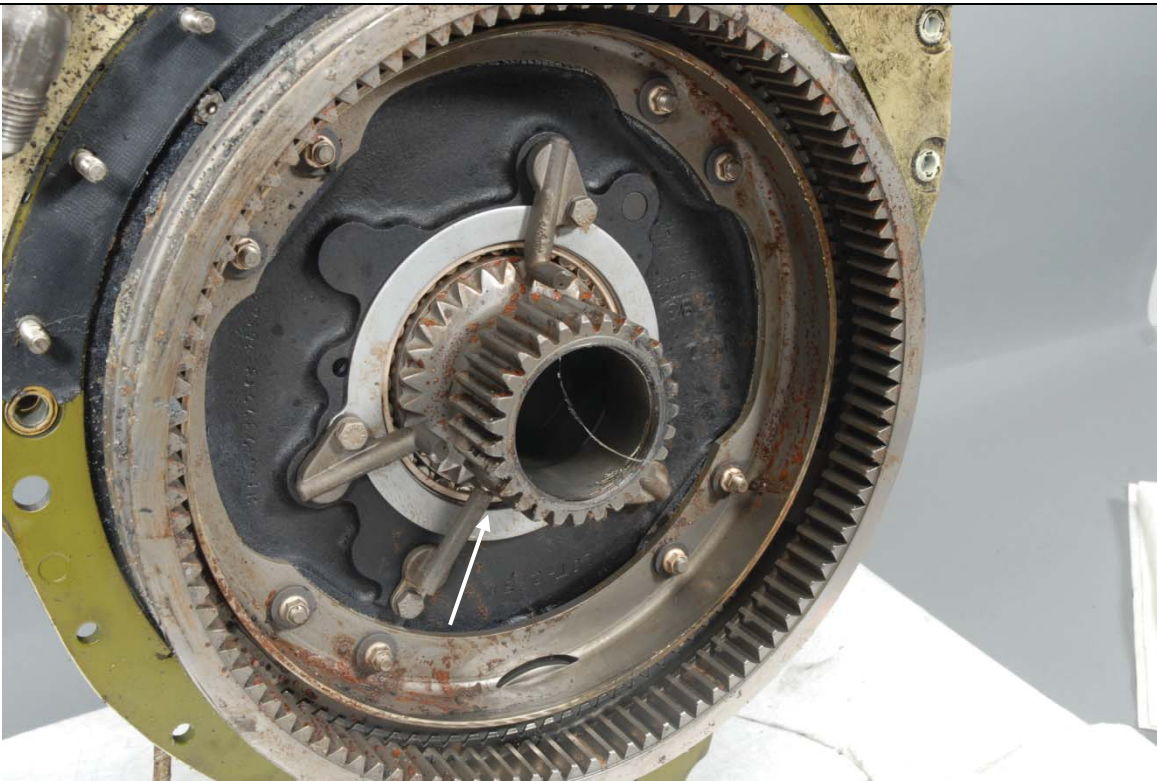
**Figure 42.** P-79297C, Sun Gear

- The aft bull-gear bearing appeared to be intact but was not removed from the diaphragm assembly.
- (i) Sun Gear:
  - The sun gear appeared to be intact, but was not removed from the diaphragm assembly. (Figure 42)

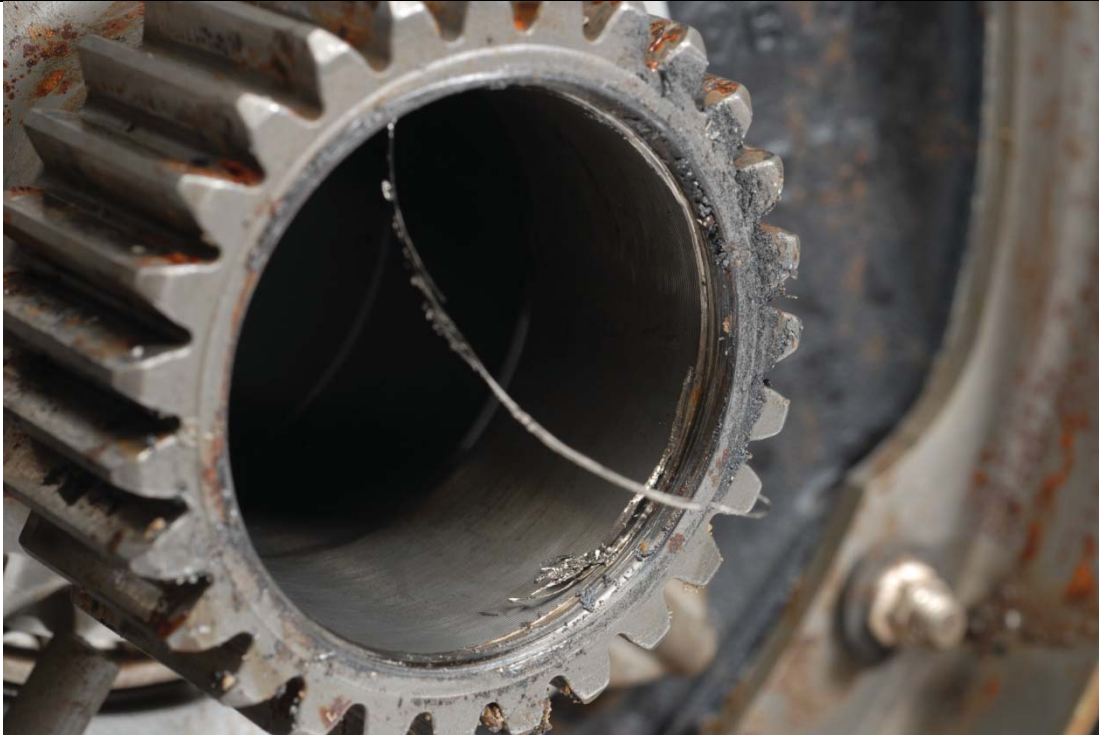
- The sun gear displayed rotational scoring on the forward, inner bore leading edge (Figure 43) with corresponding score marks on the propeller shaft immediately behind the nut.

Figure 43. P-79297C, Sun Gear, Rotational Scoring

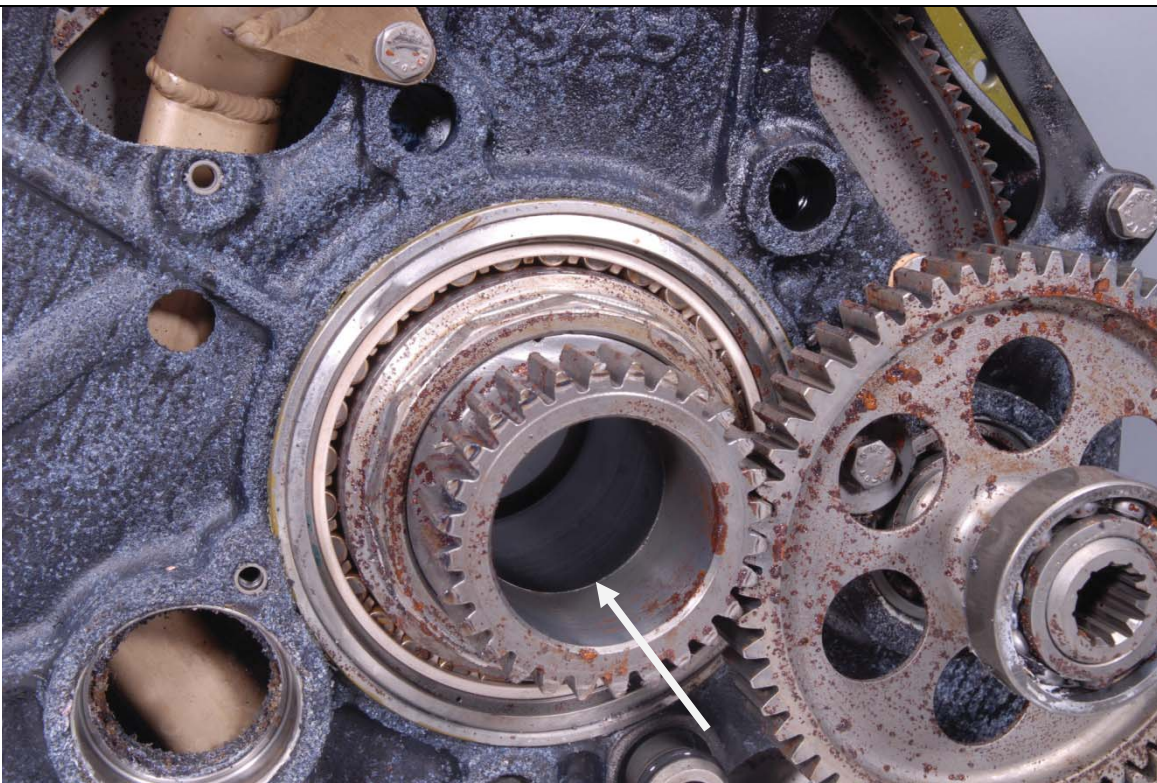
- The sun gear displayed rotational scoring on the aft inner bore (Figure 44), with corresponding rotational score marks on the aft taper of the propeller shaft.

Figure 44. P-79297C, Sun Gear, Forward Inner Bore Rotational Scoring, FLA

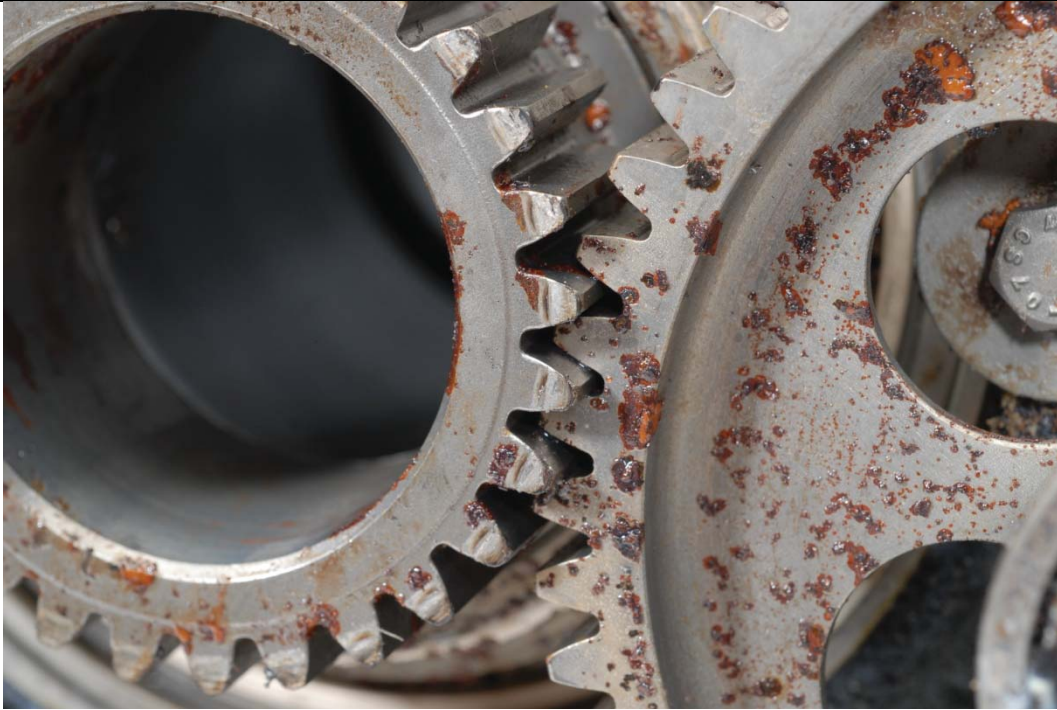
- The sun gear was gouged on the aft gear teeth. (Figure 45)
  - The bull/sun gear nut displayed rotational scoring (Figure 46) with corresponding rotational scoring to the torque sensor housing.

**Figure 45.** P-79297C, Sun Gear, Aft Face Rotational Scoring, ALF

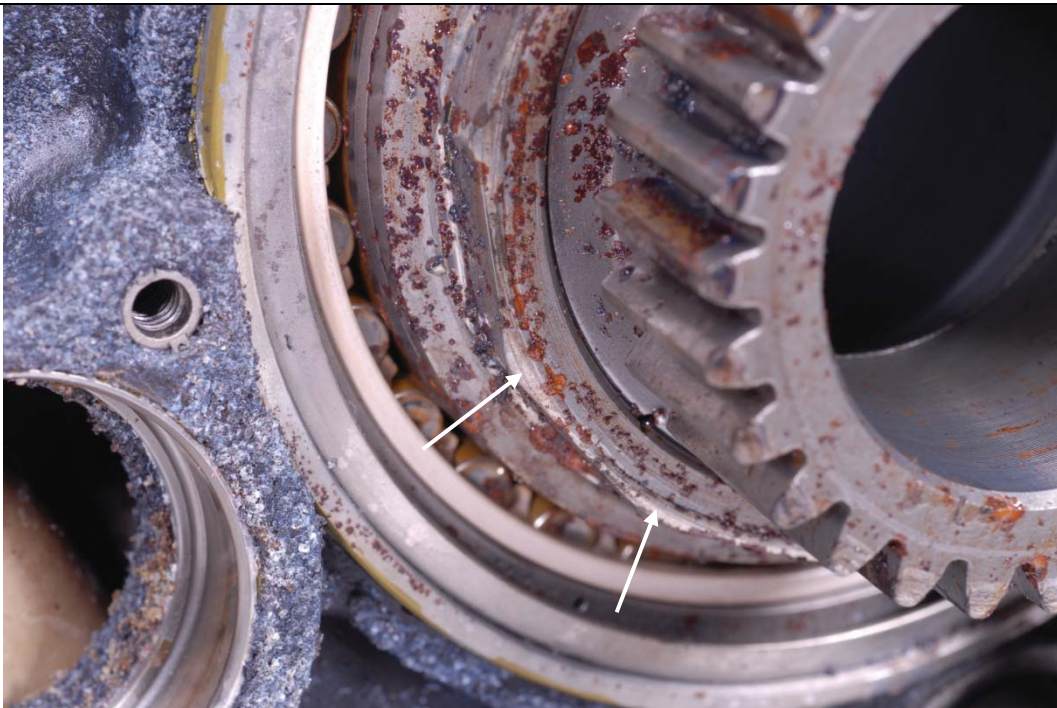
**Figure 46.** P-79297C, Sun Gear Nut Rotational Scoring, ALF

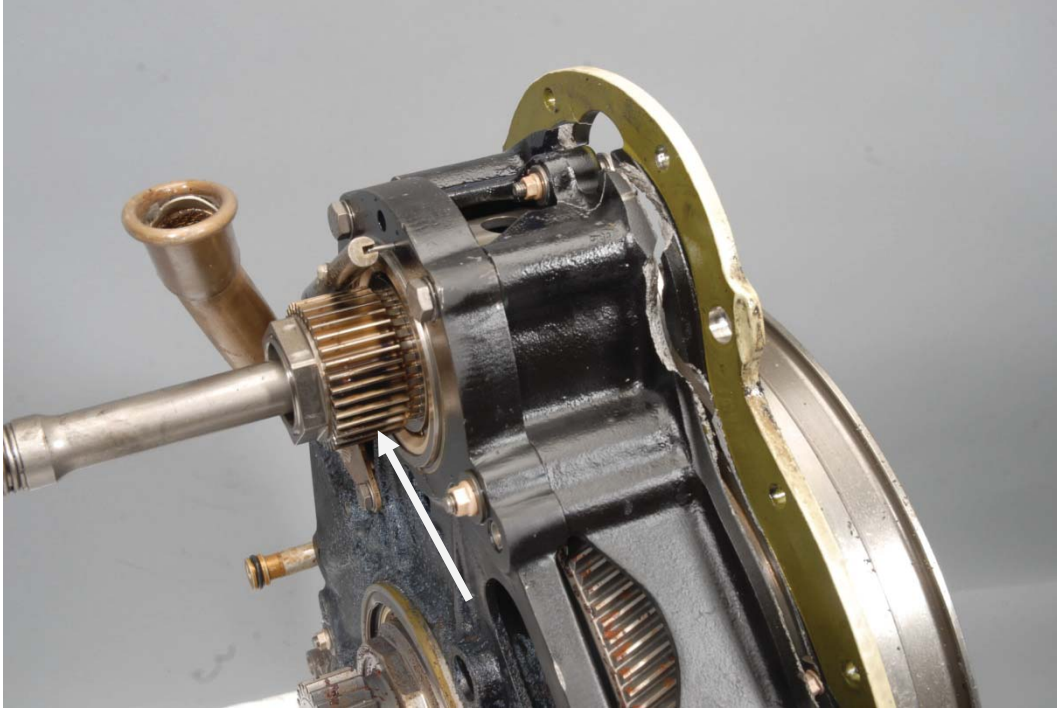
**Figure 47. P-79297C, High Speed Pinion Gear**

- (j) High-Speed Pinion (HSP): (Figure 47)
- The HSP was intact and free to rotate.
  - The HSP appeared to be undamaged, but was not removed from the diaphragm assembly for a detailed inspection.

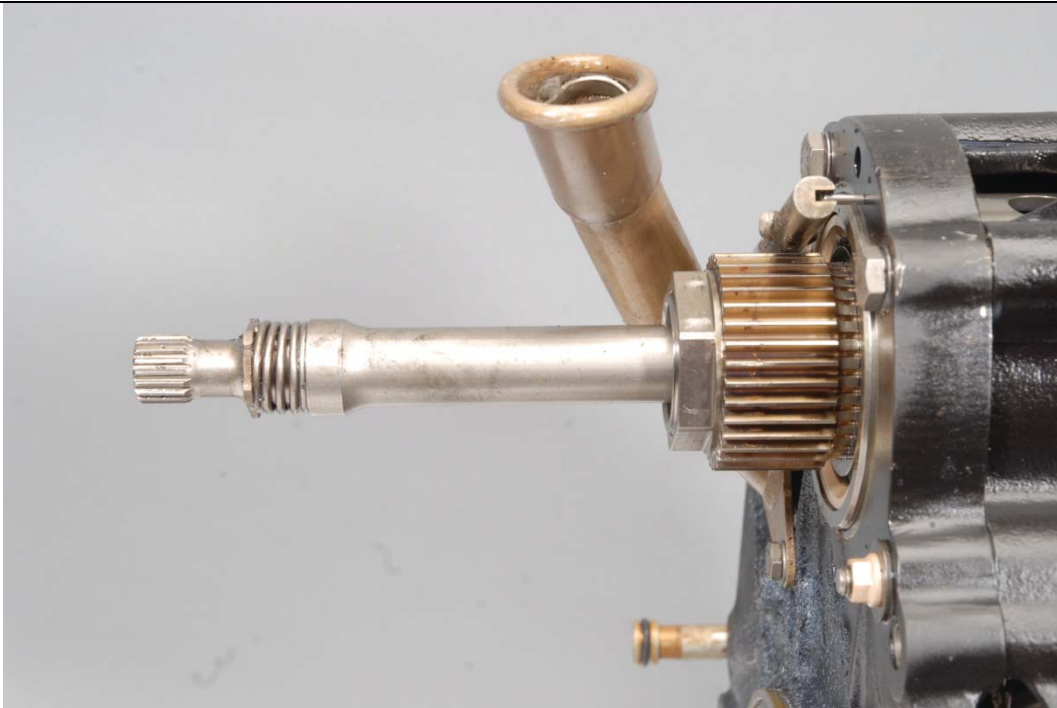
**Figure 48. P-79297C, HSP-to-Power Section Coupling Shaft Assembly**

- The aft high-speed pinion bearing was not accessed during the examination.
- (m) HSP-to-Power Section Coupling Shaft: (Figure 48)
- The HSP-to-power section coupling shaft was intact and appeared to be undamaged, but was not removed from the high-speed pinion.

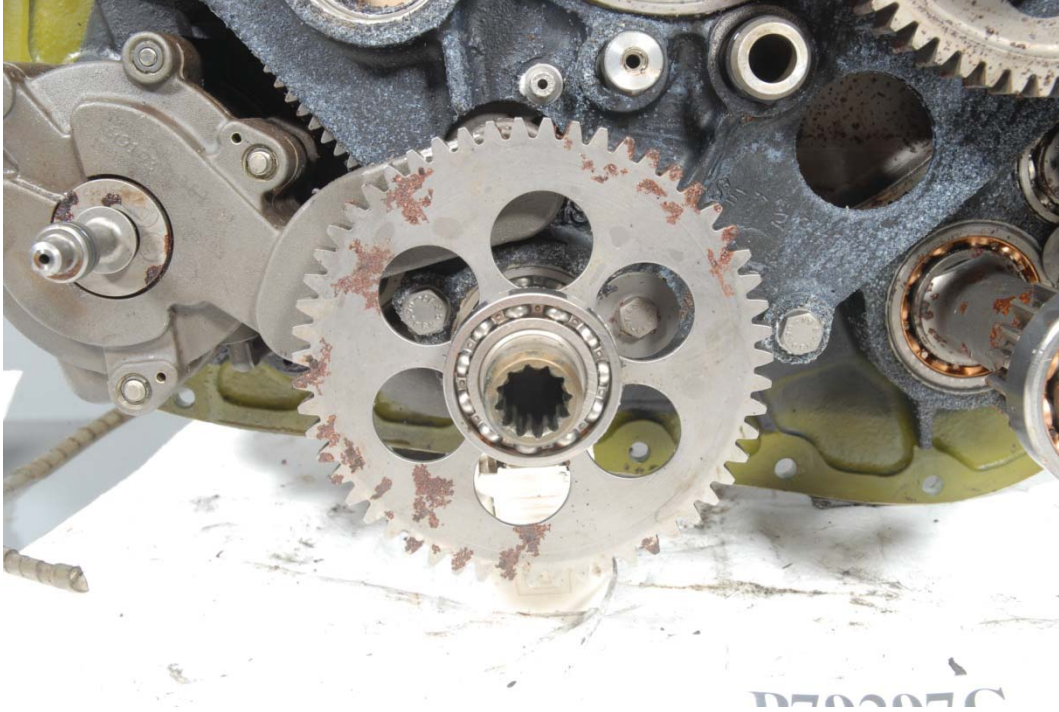
- The NTS quill shaft was not accessed during the examination.
- (p) Hydraulic Pump Drive Gearshaft Assembly: (Figure 49)
- The hydraulic pump drive gearshaft assembly was intact , but was not fully accessed in the examination.

**Figure 49.** P-79297C, Hydraulic Pump Drive Gearshaft Assembly

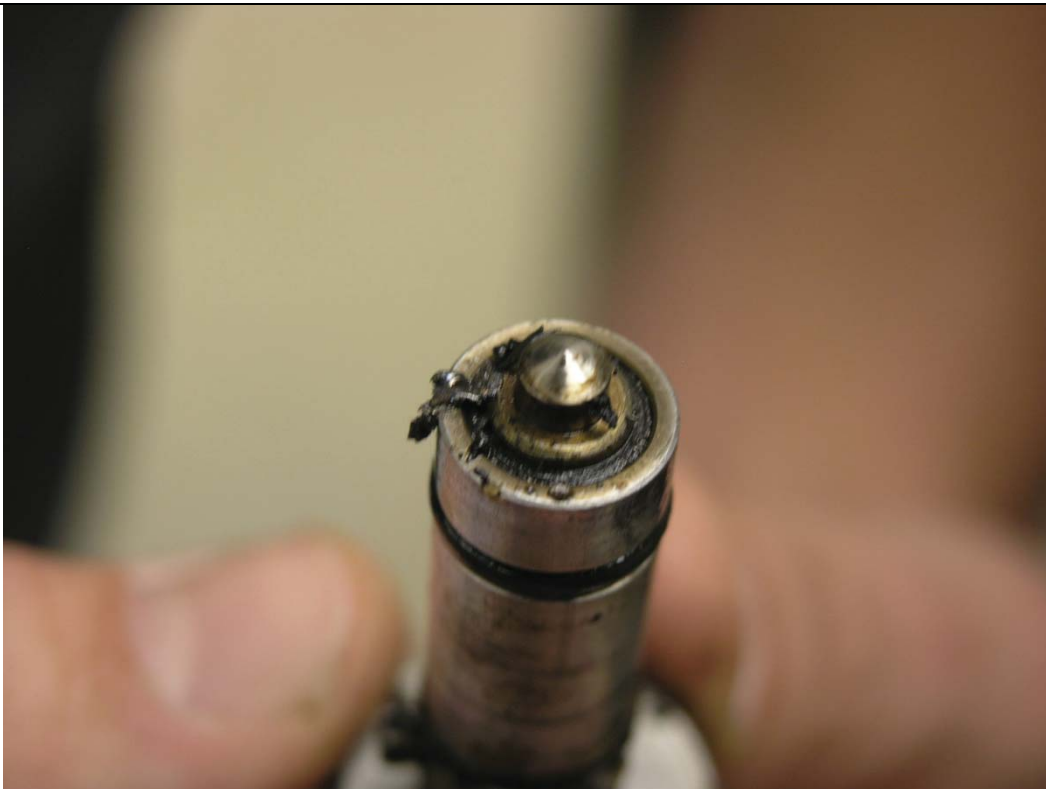
**Figure 67.** P-79297C, Compressor Air/Oil Carbon Seal Rotor, FLA

- The compressor air/oil carbon seal carbon element appeared to be undamaged.
  - The compressor air/oil carbon seal rotor was intact, but had discoloration on the sealing surface. (Figure 67)

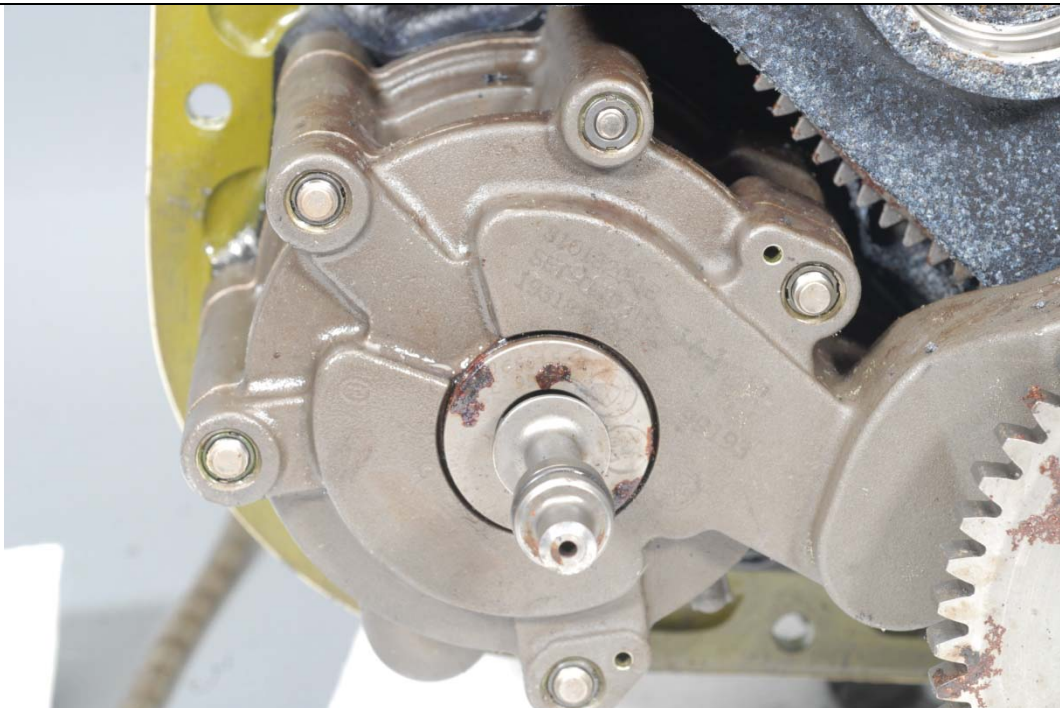
**Figure 69.** P-79297C, Oil Pressure Pump

- The magnetic drain plug (chip detector) appeared to be undamaged
- (l) Oil Pressure Pump: (Figure 69)
  - The oil pressure pump drive would not rotate.

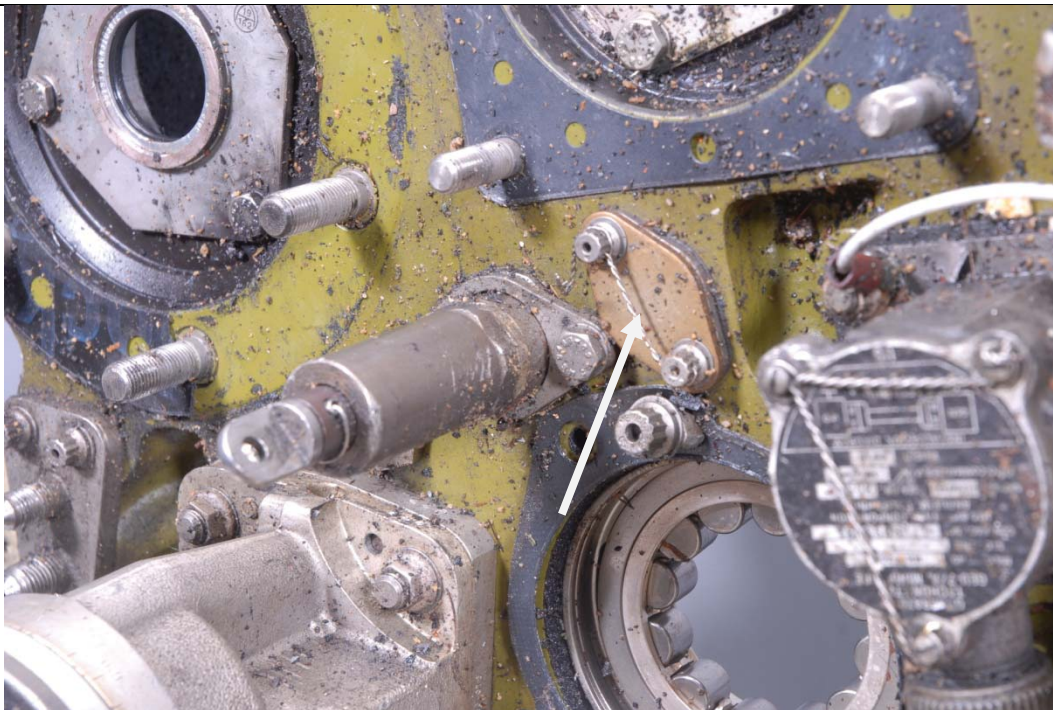
**Figure 71.** P-79297C, Gearcase Oil-Scavenge Pump Driveshaft

- The gearcase oil-scavenge pump was intact.
- (n) Gearcase Oil-Scavenge Pump Driveshaft: (Figure 71)
  - The gearcase oil-scavenge pump drive shaft was fractured.

- The gearcase oil-scavenge pump drive shaft o-ring was in place and intact.
- (o) Negative Torque Sensing (NTS) Regulator: (Figure 72)
  - The NTS regulator was not accessed.
